CO DE IDENT. NO. 81205
NUMBER	D180-18488-1
TITLE:	DVANCED TECHNICAL DATA STUDY
	PHASE IV FINAL REPORT
QUENT REVISIONS	E DATE 1/29/25 FOR THE RELEASE DATE OF SUBSE- , SEE THE REVISIONS SHEET. FOR LIMITATIONS DISTRIBUTION AND USE OF INFORMATION CON- DOCUMENT, SEE THE LIMITATIONS SHEET.
MODEL	PREPARED UNDER:
SSUE NO	CONTRACT NO.
SSUE TO	X IR&D
	☐ OTHER
	PREPARED BY A.F. Byrne
	SUPERVISED BY D. R. Duren
	APPROVED BY Lothors

This document is the report of a test of microfilmed Fully Proceduralized Job Performance Aids (FPJPA's) compared to conventional hardcopy T.O.'s.

FPJPA's were written for the SRAM Missile Program Ground Support Equipment Air Conditioning Unit (ECU) and microfilmed. The standard T.O. for the same equipment was used for comparison purposes.

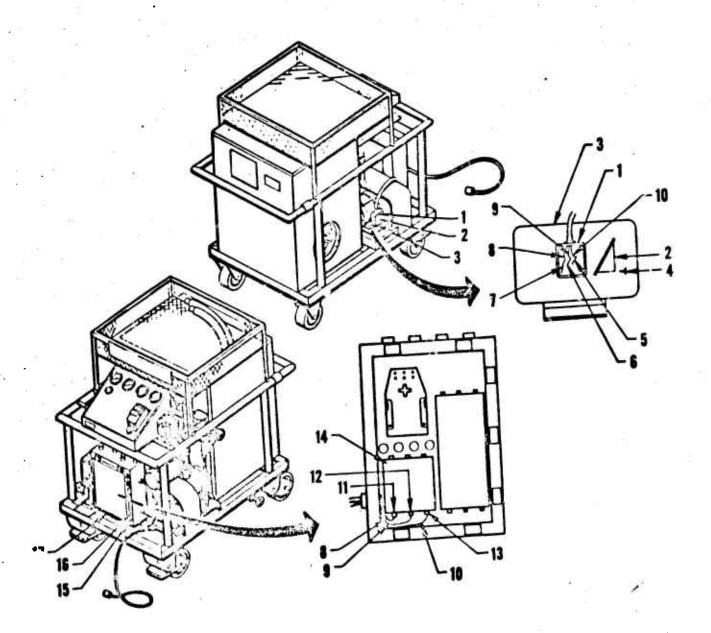
TR LESHOOT BLOWER UNIT

- 14. Remove cover (2) from conduit box
 (1) on blower motor (3) by removing screws (4).
- tor power input wires 3B14 (8),
 2B14 (9), and 1B14 (10) to blower
 motor wires C (7), B (6) and A (5)
 for signs of a poor connection. In
 a poor connection is observed,
 separate and reconnect. Refer to
 Repair of Wiring, Volume 1-6, page
 1-6-. Go to step 22.
- 16. Loosen screws (15) on electrical enclosure clamps (16).
- 17. Move clamps aside and open electrical enclosure cover (17).

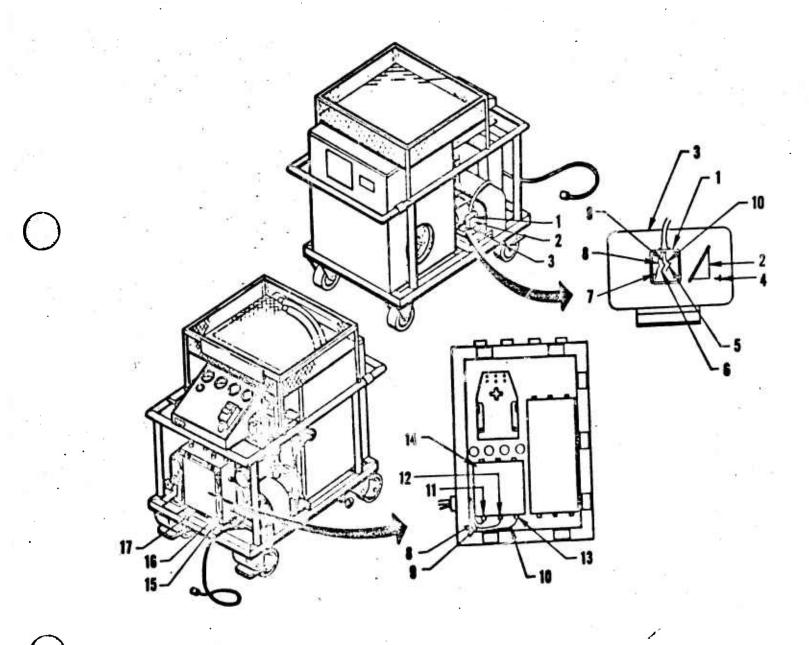
- 18. Examine connection of blower motor power input wires 3B14 (8), 2B14 (9) and 1B14 (10) to power EMI filter terminals 3 (11), 2 (12) and 1 (13). If a poor connection is observed, repair and/or reconnect. Refer to Repair of Wiring, Volume 1-6, page 1-6-. Go to step 23.
- 19. Separate connections of blower motor input wires 3B14 (8), 2B14 (9) and 1B14 (10) to blower motor wires C (7), B (6) and A (5). Refer to Repair of Wiring, Volume 1-6, page 1-6-.
- 20. Set multimeter to read ohms in the 0 to 300 ohm range and zero meter. Refer to Test Equipment Operation, Volume 1-1, page 1-1-.

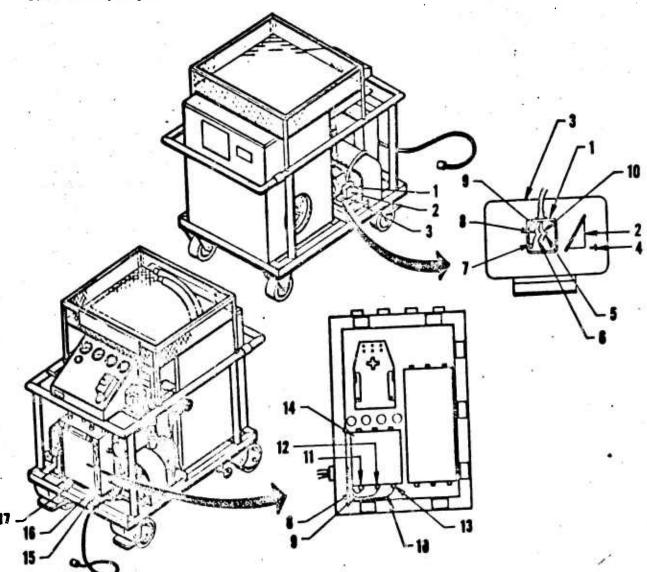
21. Place multimeter leads on each of the following sets of EMI filter terminal to blower motor power input wire checkpoints and read left to right deflection for each check:

Power EMI Filter (14) Terminals	Blower Motor (3) Power Input Wires
1 (13)	3B14 (8)
2 (12)	2B14 (9)
3 (11)	1B14 (10)

If meter deflection is observed in each check, replace blower motor

- (3). Refer to Remove and Install Variable Drive System, Volume 1-6, page 1-6-. If meter deflection is not observed in one or more of the checks, replace blower motor wire showing no deflection. Refer to Repair of Wiring, Volume 1-6, page 1-6-. Go to steps 22 and
- 22. Install cover (2) on conduit box
 (1) on blower motor (3) by in stalling screws (4). Go to step
 40.
- 23. Close electrical enclosure cover (17), position clamps (16) and tighten screws (15). Go to step 40.

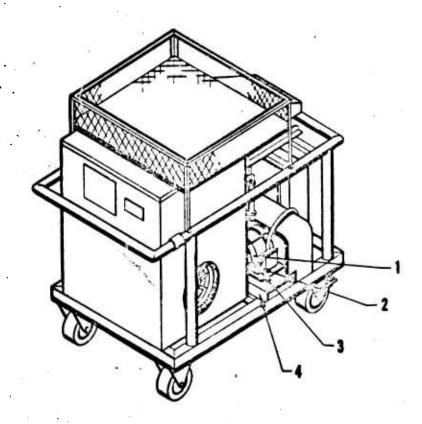
- 24. Examine blower motor mounting base (3), chassis assembly (4) and mounting bolts (2) for broken, loose or worn parts which would allow the motor to vibrate. If such a condition is found, replace or repair affected parts. Refer to Remove and Install Variable Drive System, Volume 1-6, page 1-6-.

Go to step 40.
- 25. Replace blower motor (1). Refer to Remove and Install Variable Drive System, Volume 1-6, page 1-6-.
 Go to step 40.

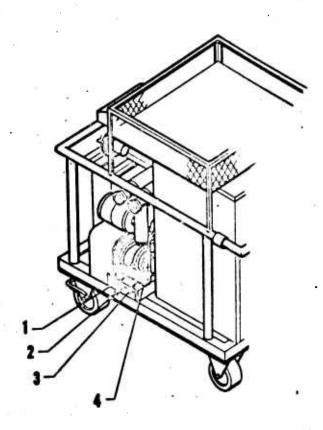
- 26. Examine blower mounting base (1), chassis assembly (2) and mounting bolts (3) for broken, loose or worn parts which would allow the blower to vibrate. If such a condition is found, replace or repair affected parts. Refer to Remove and Install Variable Drive System, Volume 1-6, page 1-6-. Go to step 40.
- 27. Replace blower (4). Refer to Remove and Install Variable Drive System, Volume 1-6, page 1-6-.
 Go to step 40.

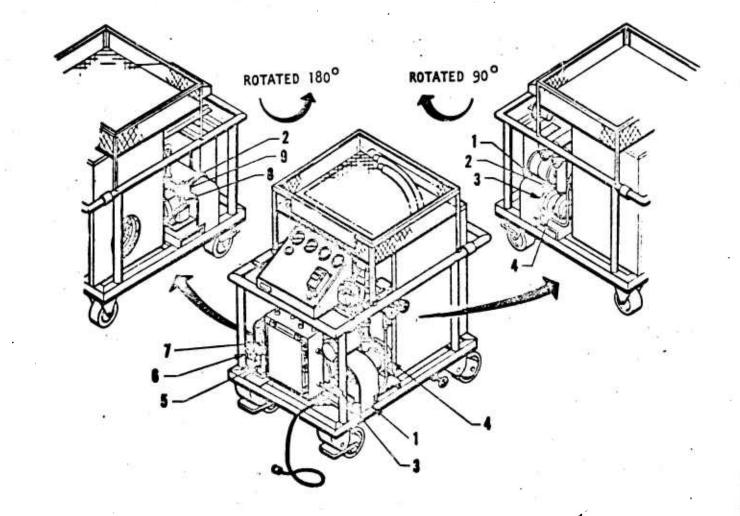
If speed adjustment was difficult or impossible, the motor pulley (9), blower pulley (3) or control bracket (5) are at fault. Each pulley has a movable face. The blower pulley is springloaded to hold the pulley faces together. When the control bracket handwheel (6) is in the outermost position, the belt (2) rides at the minimum diameter of the motor pulley and at the maximum diameter of the blower pulley. Rotation of the handwheel (6) forces the movable face of the motor pulley in, causing the belt to move out to a larger diameter position on the motor pulley and into a smaller diameter position on the blower pulley. The pulleys are packed with grease. Dirty, hard, grease

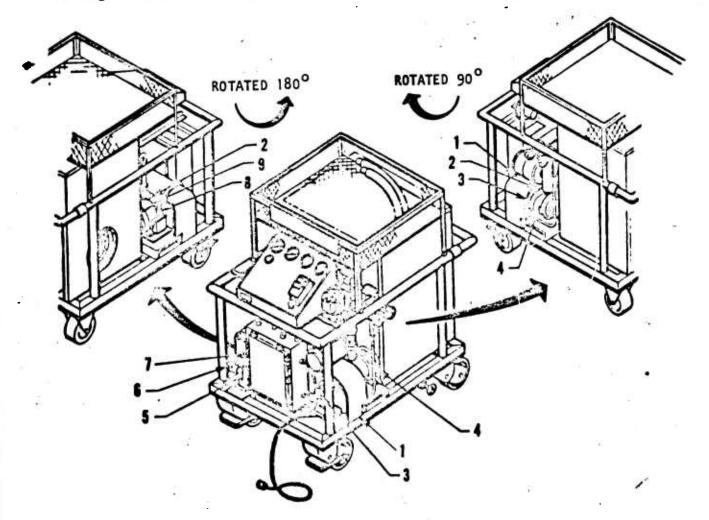
29. If belt (2) was slipping and riding up on one pulley face and speed adjustment was erratic, the variable drive system is out of alignment. Replace damaged and worn parts and realign. Refer to Remove and Replace Variable Drive System, Volume 1-6, page 1-6-and Alignment of Variable Drive System, Volume 1-6, page 1-6-. Go to step 40.

and/or worn sliding surfaces could make operation of the pulleys difficult. Damaged threads on the control bracket handwheel (6) threaded shaft could make rotation of the handwheel difficult. A pulley loose or out of position on the motor or blower shafts could cause erratic speed adjustment. The physical condition of the components will indicate the specific cause. Disassemble variable drive system, replace worn parts, flush out and lubricate pulleys, and align variable drive system. Refer to Remove and Replace Variable Drive System, Volume 1-6, page 1-6- ; Flushing Variable Drive Pulleys, Volume 1-6, page 1-6- ; and Alignment of Variable Drive System, Volume 1-6, page 1-6- . Go to step 40.

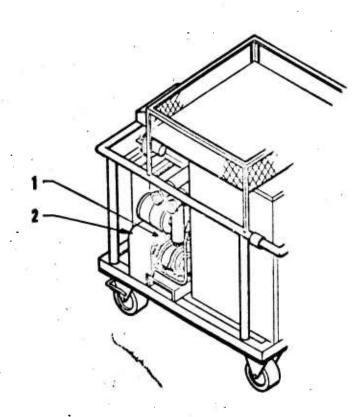
- 31. If belt guard (2) is loose or misaligned, inspect for worn, broken or bent parts. Remove belt guard and repair and/or replace parts as required. Reinstall belt guard in aligned position. Refer to Remove and Replace Variable Drive System, Volume 1-6, page 1-6-. Go to step 40.
- 32. If belt (1) is damaged or worn, replace. Refer to Remove and Replace Variable Drive System, Volume 1-6, page 1-6-. Go to step 40.

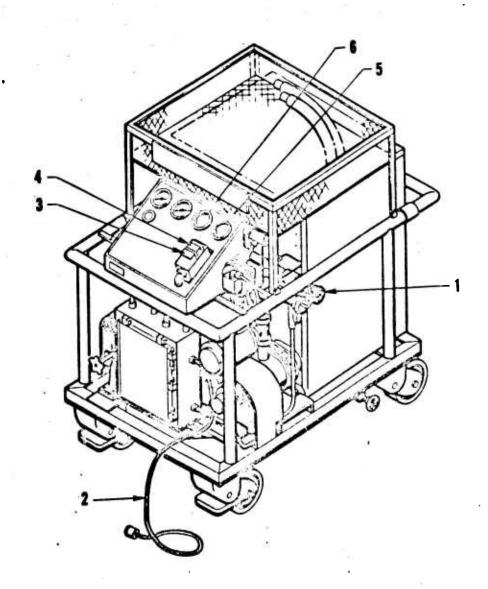
- 37. Operate unit 5 minutes or more. If relief valve (3) releases, a restriction exists in the filter (2) or piping (1). Replace filter and clean piping. Refer to Piping Repair, Volume 1-6, page 1-6-.
- 38. Press STOP switch (5).
- 39. Disconnect power cable (4) from facility power.
- 40. Return to checkout or test in progress.

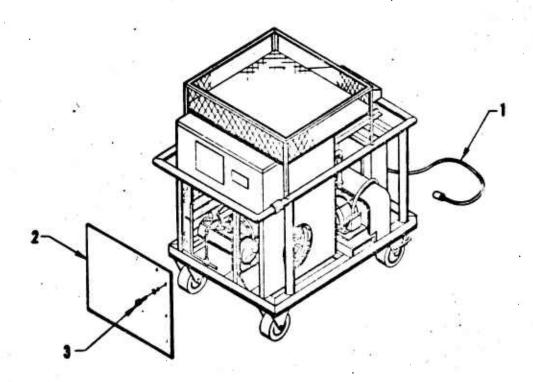
- 13. If cooling was not obtained after the AGE ECU had been stored at low ambient temperature conditions for an extended period of time, use low temperature start procedures. Refer to Preparation for Use After Extended Low Temperature Storage, Volume 1-1, page 1-1- . Continue with step 14 if cooling is not obtained or if low temperature storage was not a factor.
- 14. If cover (2) is installed, remove screws and washers (3) and remove cover (2) from cooling unit.
- 15. Connect AGE ECU power cable (1) to facility power.

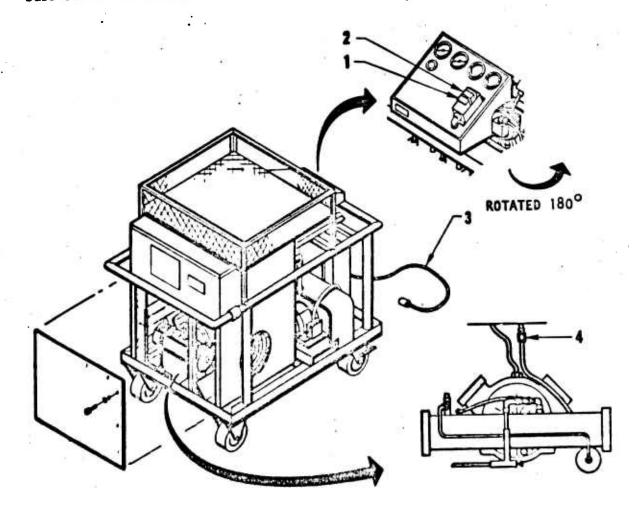
- 16. Press START switch (2).
- 17. Remove cover from refrigerator sight glass (4) and check that refrigerator sight glass is clear and free of bubbles. If not, press STOP switch (1) and disconnect AGE ECU power cable (3) from facility power. Go to step 8.

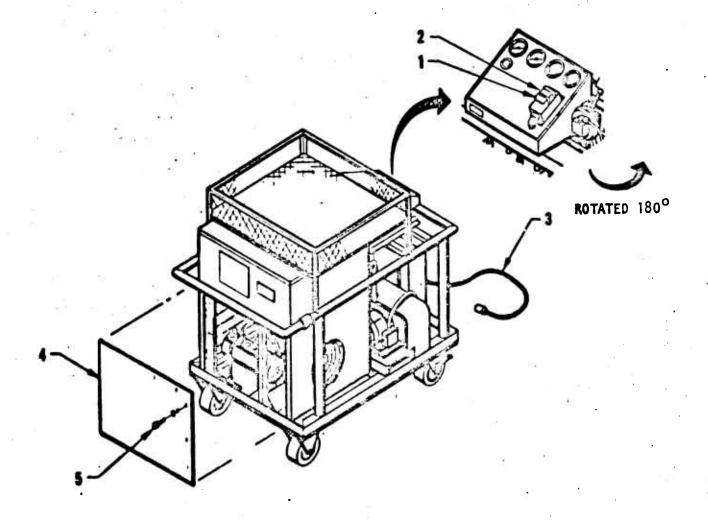
- 18. Press STOP switch (1), place back cover (4) on cooling unit and install washers and screws (5).
- 19. Press START switch (2) and allow the AGE ECU to operate for 10 to 15 minutes.
- 20. Press STOP switch (1) and disconnect AGE ECU power cable (3) from facility power.

- 21. Remove screws and washers (5) and remove cover (4) from cooling unit.
- 22. If repeated automatic shutdown because of pressure limit control HI-LOW pressure switch cutout was the trouble, go to step 39. If lack of cooling was the trouble, continue with step 23.

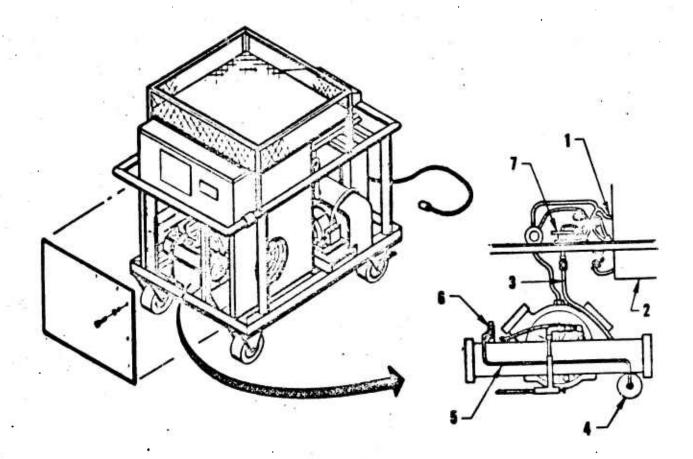
- 23. Check the liquid line (5) from the shutoff valve V5 (6) to the filter-drier (4) and the liquid line (3) from the filter-drier (4) to the expansion valve V1 (7) for sweating or frost. If sweating or frost is observed, go to step 31.
- 24. Check the suction line (1) from the expansion valve V1 (7) to the evaporator (2) for a distinctly colder surface than the liquid line (3) surface. If a colder surface is not observed, the expansion valve V1 (7) is closed or obstructed. Remove and replace expansion valve V1 (7). Refer to Repair of Cooling Unit, Volume 1-7, page 1-7-

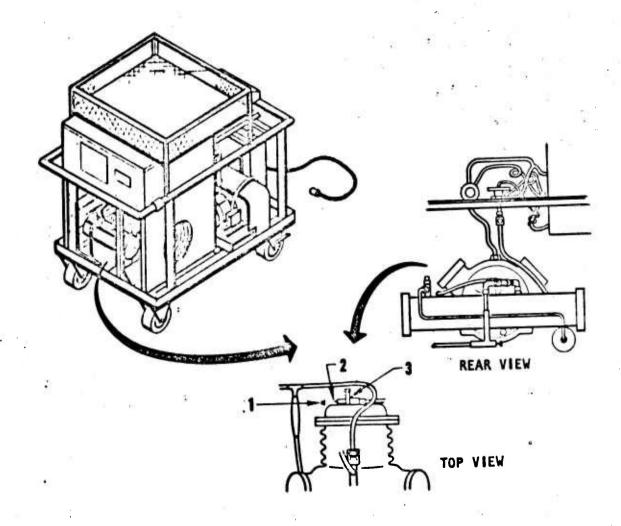
- 25. Check suction service valve V7 (3) for full open by removing seal cap (1), placing handwheel or wrench on valve stem (2) and attempting to rotate valve stem counterclockwise.
- 26. If valve V7 (3) was not fully opened, as indicated by the valve stem rotating, continue to rotate valve stem (2) until the suction service valve V7 (3) is backseated. Remove handwheel or wrench, install seal cap (1) and go to step 119.
- 27. If valve V7 (3) cannot be opened further, attempt to close valve V7(3) by rotating handwheel or wrench clockwise.
- 28. If valve V7 (3) operates easily, reopen valve V7 until backseated, by rotating handwheel or wrench counterclockwise and install seal cap (1). Go to step 30.
- 29. If valve V7 (3) does not operate easily, remove and replace valve V7 (3). Refer to Repair of Cooling Unit, Volume 1-7, page 1-7-.

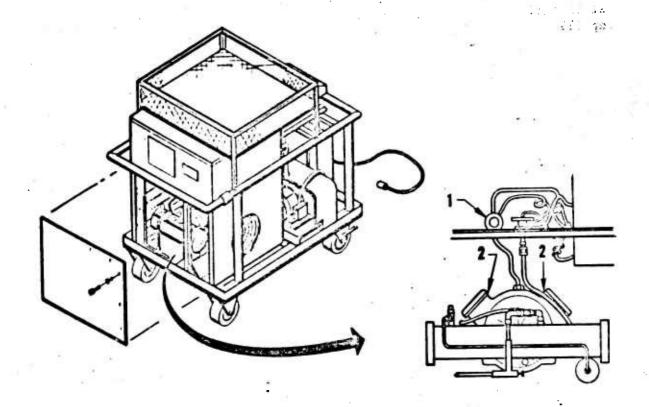
30. Check the hot gas bypass valve V2
(1) for correct setting. Refer to
Adjustment of Hot Gas Bypass Valve
V2, Volume 1-7, page 1-7- . If
suction pressure cannot be reduced
when making check, remove and re-

place compressor valve plate assemblies (2). Refer to Repair of Compressor, Volume 1-8, page 1-8-. If hot gas bypass valve V2 (1) will not close when making check, remove and replace valve V2 (1). Refer to Repair of Cooling Unit, Volume 1-7, page 1-7-

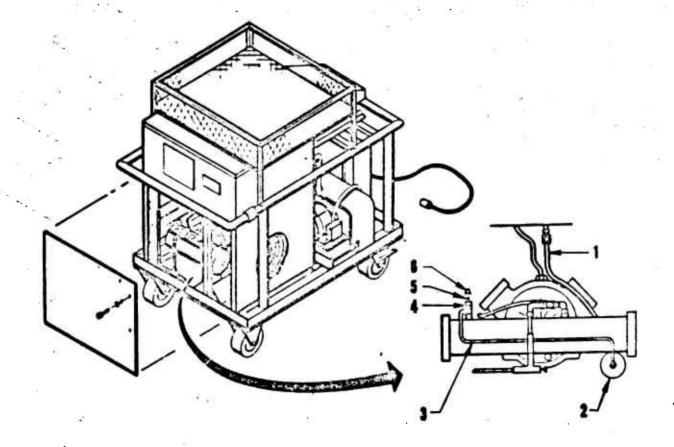
- 31. Determine the location, downstream from the line shutoff valve V5 (4), where the sweating or frost begins.
- 32. If the location is at the filter-drier (2), remove and replace the filter-drier (2). Refer to Repair of Cooling Unit, Volume 1-7, page 1-7-.
- 33. If the location is in line (1) or in line (3), replace affectedline. Refer to Repair of CoolingUnit, Volume 1-7, page 1-7-

- 34. If the location is at the line shutoff valve V5 (4), remove the seal cap (6), place handwheel or wrench on valve stem (5) and attempt to rotate valve stem (5) counterclockwise.
- 35. If valve stem (5) rotates counterclockwise, continue to rotate until the valve V5 (4) is backseated. Remove handwheel or wrench, install seal cap (6) and go to step 119.

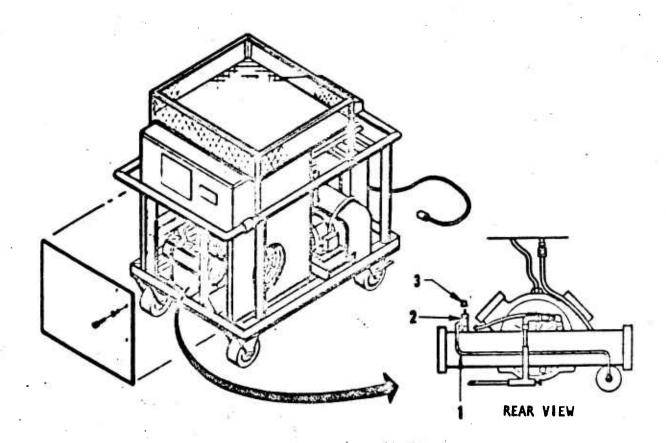
- : JBLESHOOT COOLING UNIT
- 36. If valve V5 (2) cannot be opened further, attempt to close valve V5 (2) by rotating handwheel or wrench clockwise.
- 37. If valve V5 (2) operates easily, reopen valve V5 until backseated, by rotating handwheel or wrench counterclockwise. Remove handwheel or wrench and install seal cap (3). Remove and replace line (1). Refer to Repair of Cooling Unit, Volume 1-7, page 1-7-
- 38. If valve V5 (2) does not operate easily, remove and replace valve V5. Refer to Repair of Cooling Unit, Volume 1-7, page 1-7-.

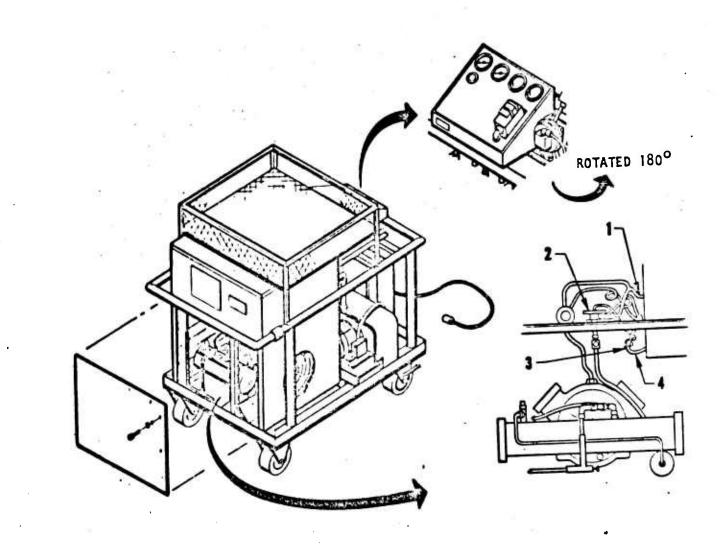
- 39. Check suction line (1) for cold or frosted surface. If line is not cold or frosted, go to step 23 and troubleshoot for lack of cooling.
- 40. Check expansion valve VI thermal bulb (3) for tight mounting against suction line (4) and insulation over thermal bulb (3) for tight and secure installation.
- 41. If thermal bulb or insulation is not properly mounted, resecure in place. Refer to Installation of Expansion Valve, Volume 1-7, page 1-7-. Go to step 119.
- 42. If thermal bulb and insulation are firmly in place, replace expansion valve V1 (2). Refer to Repair of Cooling Unit, Volume 1-7, page 1-7-.

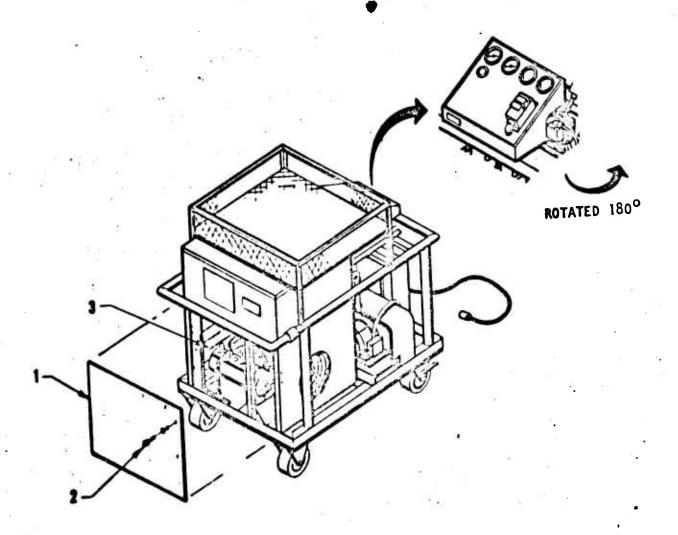
43. If cover (1) is installed, remove screws and washers (2) and remove cover from cooling unit.

Verify power cable is disconnected from facility power before making inspection. Injury could result if AGE ECU were started. 44. Inspect condenser (3) for clogging with debris. If condenser (3) is clogged with debris, remove debris. Refer to Cleaning of Condenser, Volume 1-9, page 1-9-.

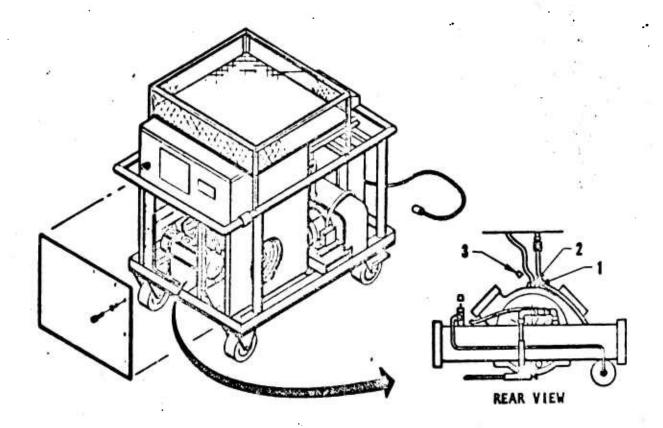
- 45. Check head pressure service valve V8 (1) for full open by removing seal cap (3), placing handwheel or wrench on valve stem (2) and attempting to rotate valve stem counterclockwise.
- 46. If valve V8 was not fully open, as indicated by the valve stem rotating, continue to rotate valve stem (2) until the valve V8 (1) is backseated. Remove handwheel or wrench, install seal cap (3) and go to step 119.
- 47. If valve V8 (1) cannot be opened further, attempt to close valve V8 (1) by rotating handwheel or wrench clockwise.
- 48. If valve V8 (1) operates easily, reopen valve V8 until backseated by rotating handwheel or wrench counterclockwise and install seal cap (3). Go to step 119.
- 49. If valve V8 does not operate easily, remove and replace valve V8
 (1). Refer to Repair of Cooling
 Unit, Volume 1-7, page 1-7

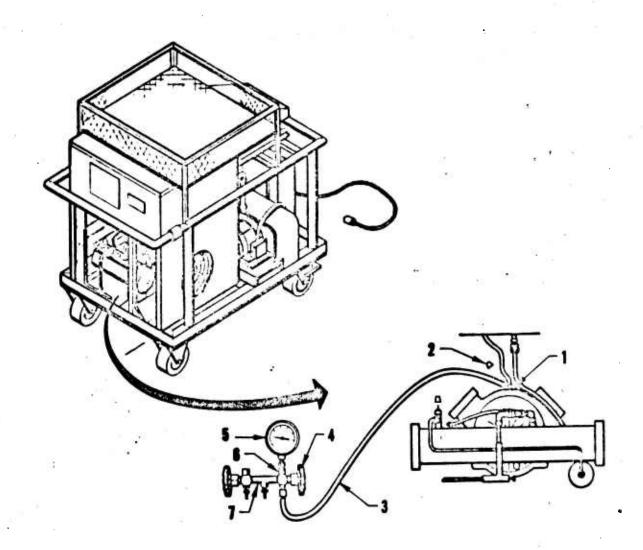
- 50. Allow the cooling unit to stand idle long enough for the refrigeration system to cool to ambient temperature.
- 51. Remove cap (2) from head pressure service valve V8 (1).
- 52. Connect charging hose to head pressure service valve V8 (1).

- 53. Connect charging manifold (7) to charging hose (3).
- 54. Screw high pressure gage (5) into charging manifold (7) port which is directly opposite charging hose (3).
- 55. Turn handwheel (4) on charging manifold (7) valve nearest gage clockwise until valve is bottom-seated in innermost position.

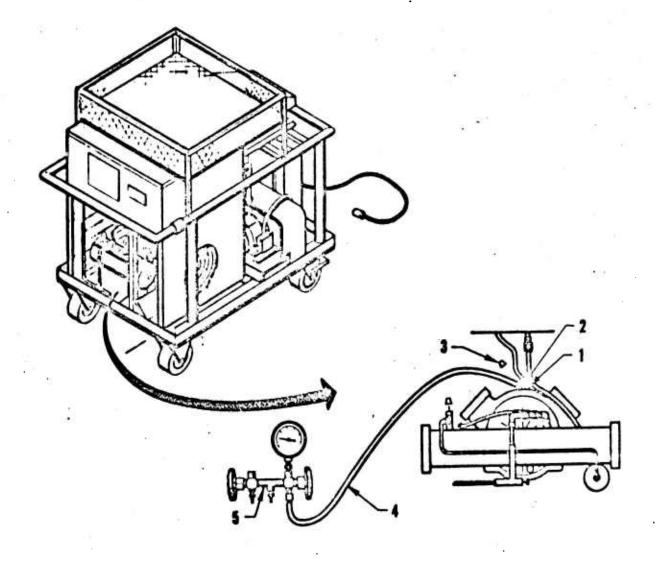
- 56. Loosen charging hose (4) at manifold (5).
- 57. Remove seal cap (3) from head pressure service valve V8 (1).
- 58. Install handwheel or wrench on valve stem (2) of head pressure service valve V8 (1).

59. Slowly turn valve stem (2) approximately two turns clockwise into valve, allow enough freon refrigerant to escape to purge charging hose (4), then tighten charging hose at manifold.

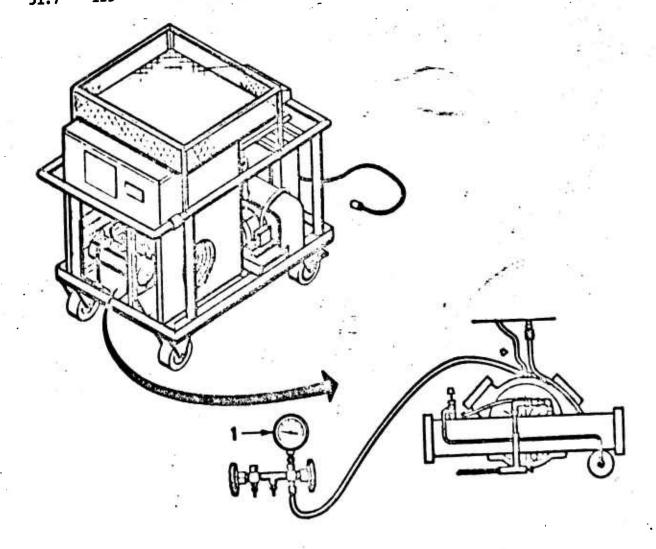
- TI 3LESHOOT COOLING UNIT
- 60. Read high pressure indication on high pressure gage (1).
- 61. Find ambient temperature in table below and read corresponding pressure.

- 62. If pressure on gage (1) is less than 10 psig above pressure read from table, go to step 69.
- 63. If pressure on gage (1) is more than 10 psig above pressure read from table, there is air in refrigerant. Continue with step 64 following.

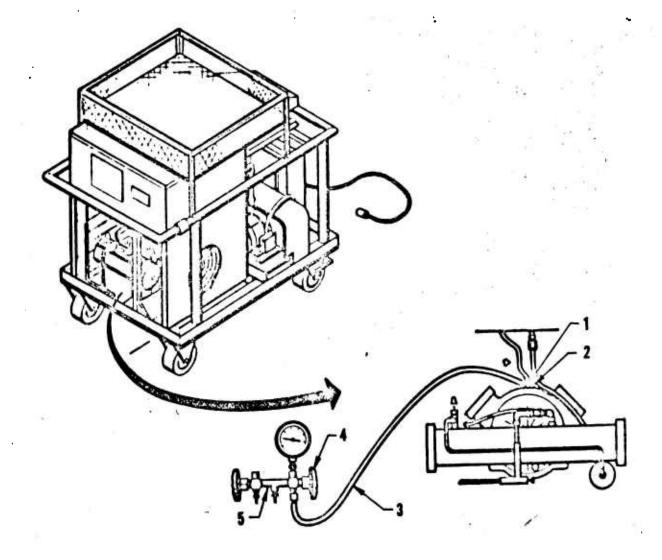
64. With handwheel or wrench, turn valve stem (1) of head pressure service valve V8 (2) counterclockwise until valve is backseated at outermost position (approximately two turns).

- 65. Open manifold valve (4) slowly to allow freon refrigerant to bleed from manifold (5) and charging hose (3).
- 66. Disconnect charging hose (3) from head pressure service valve V8 (2).

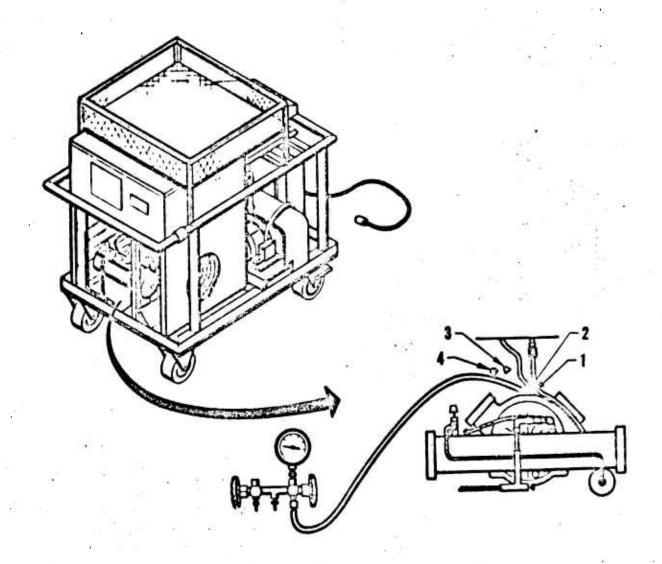
- 67. Install cap (4) and seal cap (3) on head pressure service valve V8 (1).
- 68. Recharge cooling unit with refrigererant. Refer to Charging Refrigeration System, Volume 1-7, page 1-7-
- 69. With handwheel or wrench, turn valve stem (2) of head pressure service valve V8 (1) counterclockwise until valve is backseated at outermost position (approximately two turns).
- 70. With handwheel or wrench, slowly turn valve stem (2) of head pressure service valve V8 (1) clockwise approximately one-half turn into valve.

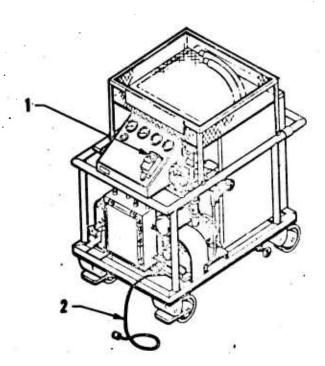
71. Connect AGE ECU power cable (2) to facility power.

72. Press START switch (1).

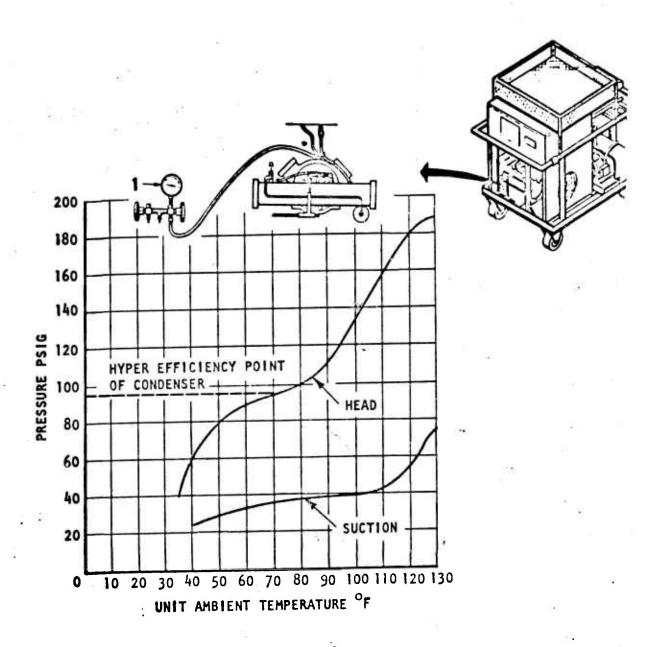
- 73. Read high pressure gage (1) indication.
- 74. Read head pressure from chart for ambient temperature.
- 75. Compare pressure read on pressure gage with pressure read from chart. The pressure read on the pressure gage must be less than 5 psig over the pressure read on the chart. If the pressure is out of tolerance, go to step 82.

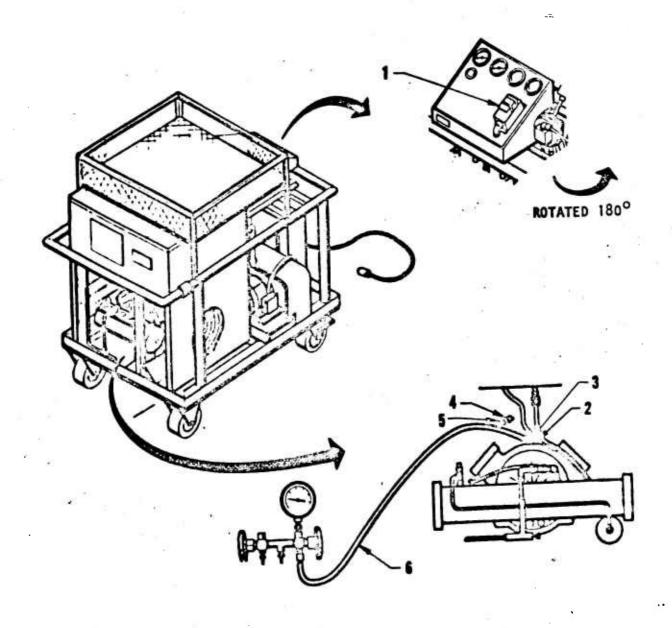
- 76. Press STOP switch (1).
- 77. With handwheel or wrench, turn valve stem (3) of head pressure service valve V8 (2) counterclockwise until backseated (approximately one-half turn).
- 78. Install seal cap (4) on head pressure service valve V8 (2).

- 79. Disconnect charging hose (6) from head pressure service valve V8 . (2).
- 80. Install cap (5) in head pressure service valve V8 (2) gage port.
- 81. Troubleshoot pressure limit control. Refer to AGE ECU Cooling
 Unit Pressure Limit Control (Lear-Siegler) Troubleshoot, Volume
 2-10.

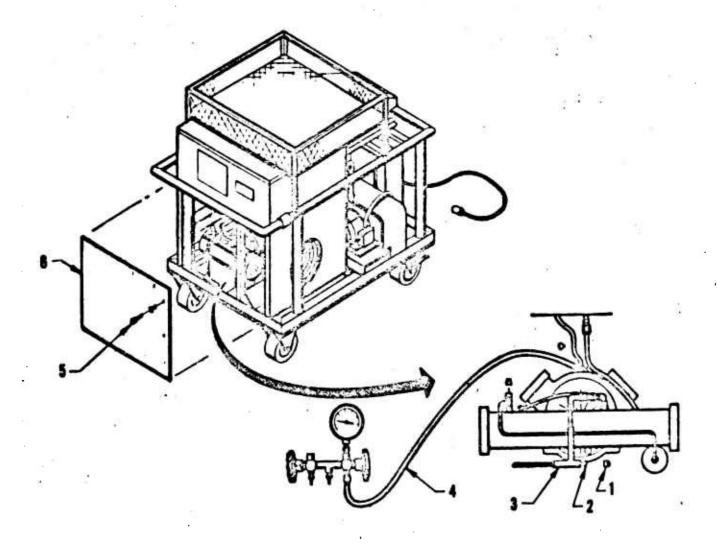
- T BLESHOOT COOLING UNIT
- 82. Remove protective cap (1) from head pressure control valve V4 (3) adjustment screw (2).
- fourth turn counterclockwise. Let
 AGE ECU run 2 minutes and read
 pressure gage. Make further adjustments, turning screw (2) onefourth turn or less at a time and
 waiting 2 minutes between settings
 to read pressure gage. If satisfactory adjustment is accomplished, reinstall protective cap (1)
 and go to step 112.
- 84. If adjustment of head pressure control valve V4 (3) did not reduce head pressure to within tolerance, reinstall protective cap (1) and install back cover (6) in a temporary manner. Use padding around charging hose (4) and install approximately half of the screws (5).

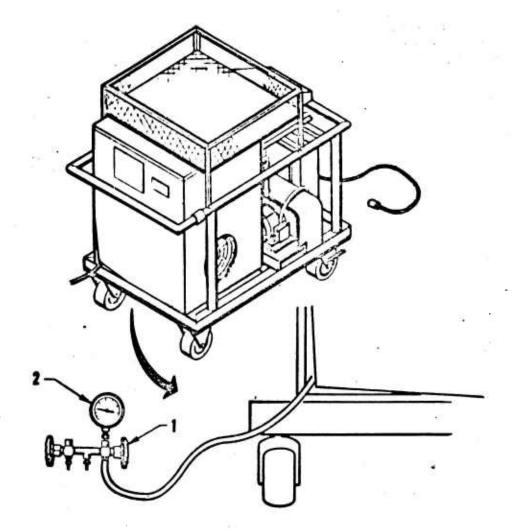
- 85. Observe head pressure for 5 minutes as AGE ECU continues to run to determine if head pressure will stabilize. If head pressure stabilizes within tolerance, go to step 112.
- 86. Open manifold valve (1) slowly and allow a small amount of freon refrigerant to bleed off. Close manifold valve (1). Allow head pressure to stabilize. Then read pressure gage (2) indication.
- 87. If pressure decreased, bleed off another small increment if required to bring head pressure within tolerance. Go to step 112.
- 88. If pressure did not decrease with release of a small quantity of refrigerant, discontinue attempt and continue with step 89 following.

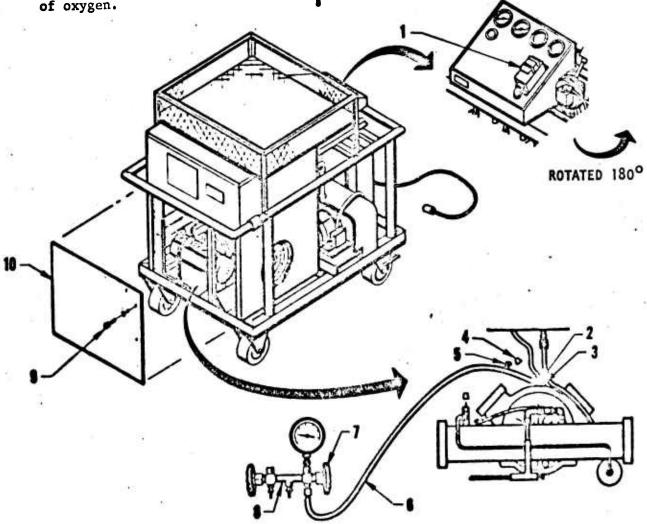
- 89. Press STOP switch (1).
- 90. Remove back cover (10) by removing screws (9) and padding.
- 91. With handwheel or wrench, turn valve stem (2) of head pressure service valve V8 (3) counterclockwise until valve is backseated at outermost position (approximately one-half turn).

- 92. Open manifold valve (7) slowly to allow freon refrigerant to bleed from manifold (8) and charging hose (6).
- 93. Disconnect charging hose (6) from head pressure service valve V8 (3).
- 94. Install cap (5) and seal cap (4) on head pressure service valve V8 (3).
- 95. If head pressure is set satisfactorily, go to step 118.

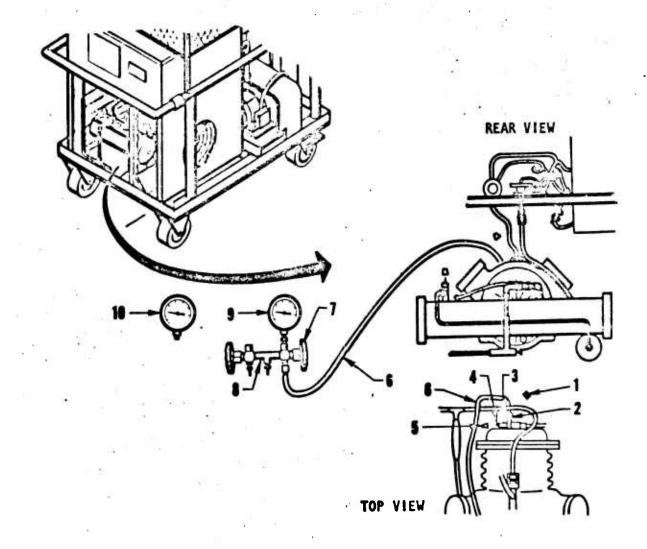
- 96. Remove cap (1) from gage port (2) of suction service valve V7 (3).
- 97. Connect charging hose (6) from manifold (8) to gage port (2).
- 98. Remove high pressure gage (10) from manifold (8).
- 99. Install compound pressure gage (9) on manifold (8) at location from which high pressure gage was removed.

- 100. Close manifold valve (8) by rotating handwheel (7) clockwise until valve is bottomseated.
- 101. Remove seal cap (5) from suction service valve V7 (3).
- 102. With handwheel or wrench, turn valve stem (4) clockwise into suction service valve V7 until valve is closed (bottomseated).

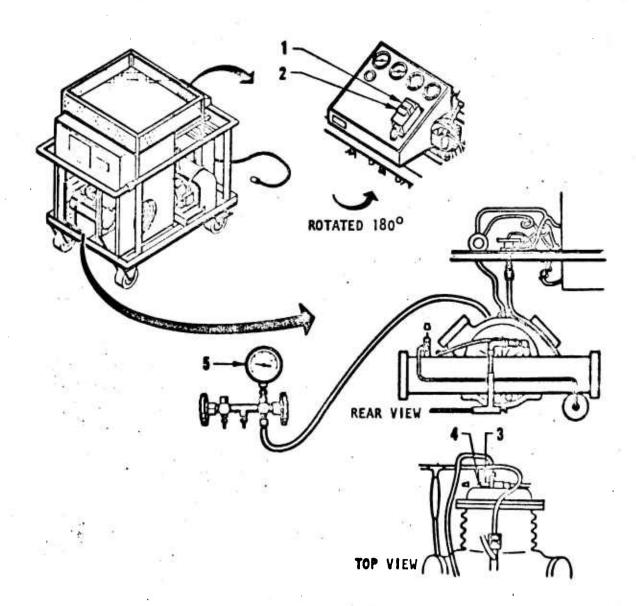
- 103. Press START switch (1) and allow AGE ECU to run until a vacuum of 10 to 15 inches of mercury is indicated on compound pressure gage (5).
- 104. Press STOP switch (2).

- 105. With handwheel or wrench, turn valve stem (4) of suction service valve V7 (3) counterclockwise to open slightly. Watch pressure gage (5) and close suction service valve V7 (3) tightly when pressure gage reads zero.
- 106. Watch pressure gage (5) for 5 minutes for continuing pressure rise. Note whether a pressure rise was observed.

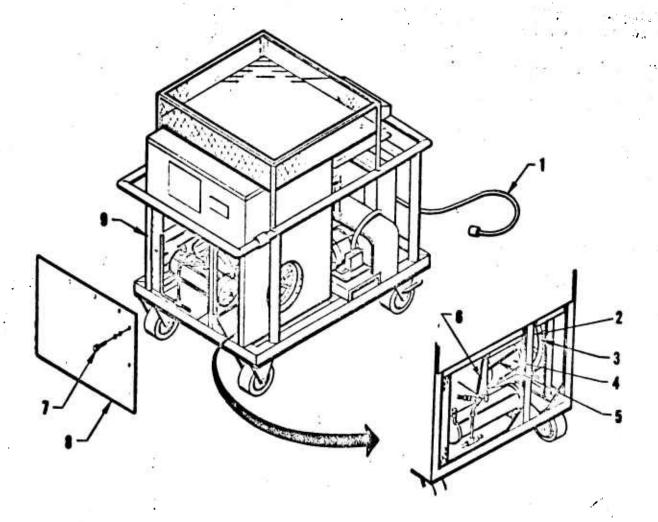
3. Manually jiggle condenser fan motor (4) to determine that motor is not loose or misaligned in its mounting. If motor is loose or misaligned, look for loose or broken motor mount (6), motor mount strap (5) or fan ring bracket (3). Replace broken parts and remount motor. Refer to Remove and Install Fan Motor, Volume 1-9, page 1-9-. Go to step 17.

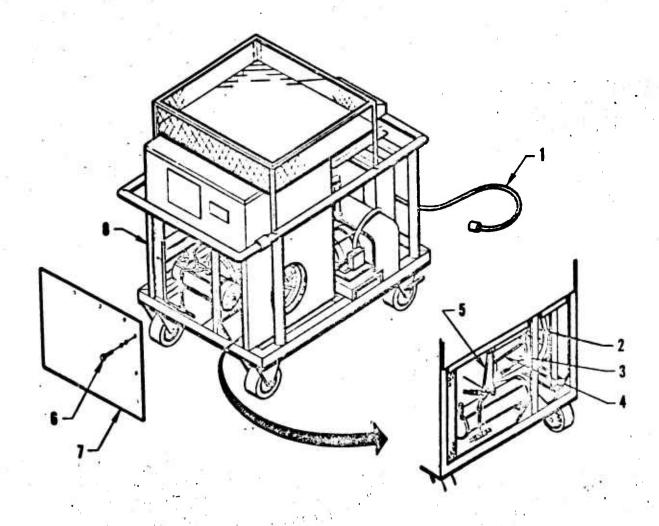
TROUBLESHOOT CONDENSER FAN NOISY OR DOES NOT RUN

- 4. Manually rotate fan (2) to determine that fan is not loose on fan motor (3) shaft. If fan is loose, tighten or replace fan. Refer to Remove and Install Condenser Fan, Volume 1-9, page 1-9- . Go to step 17.
- 5. Manually rotate fan (2) to determine that fan blades are not bent. If fan blades are bent, replace fan. Refer to Remove and Install Condenser Fan, Volume 1-9, page 1-9-. Go to step 17.
- 6. Manually rotate fan (2) to determine that fan motor turns freely.

If not, replace fan motor (3). Refer to Remove and Install Fan Motor, Volume 1-9, page 1-9-. Go to step 17.

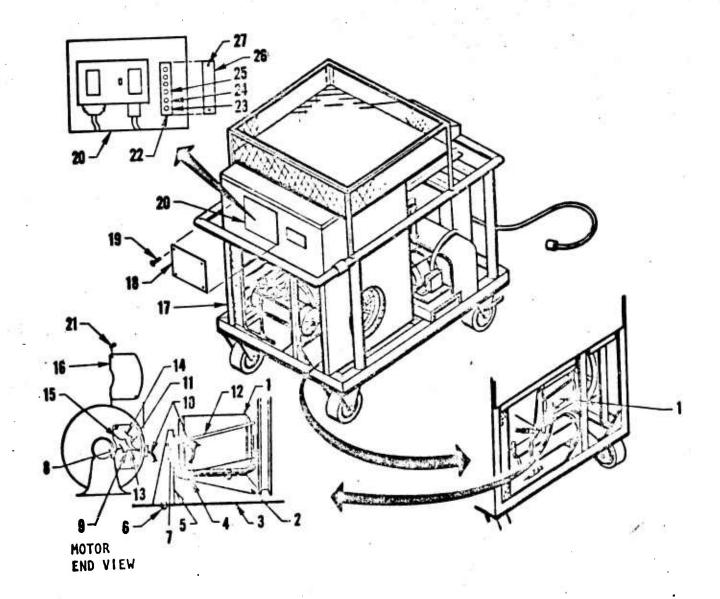
: UBLESHOOT CONDENSER FAN NOISY OR DOES NOT RUN

7. Remove cover (18) from electrical box (20) on cooling unit (17) by removing screws and lockwashers (19).

- 8. Remove cover (26) from terminal board TB-1 (22) by removing two screws (27).
- 9. Remove nuts and washers (7) which fasten fan motor strap (12) to fan motor mount (5) and remove fan motor mount strap (12).
- 10. Remove two bolts (6) which fasten fan motor mount (5) to frame floor (3).

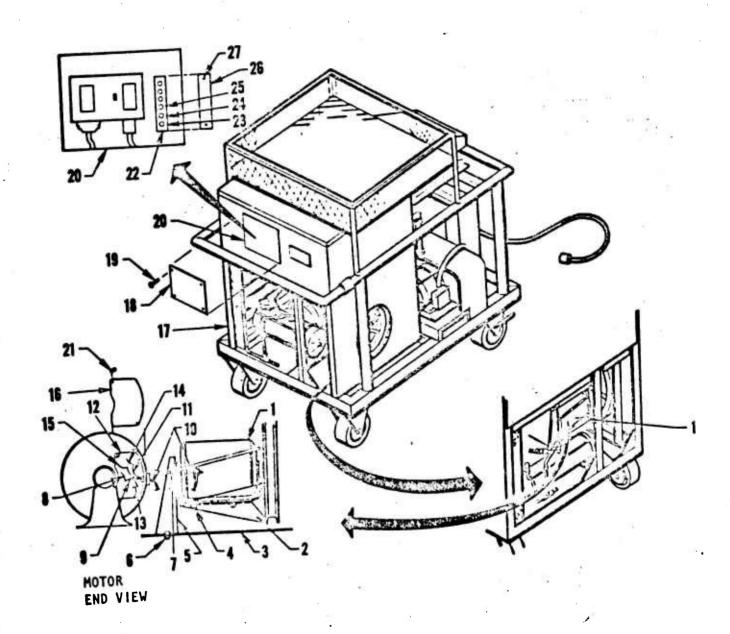
TROUBLESHOOT CONDENSER FAN NOISY OR DOES NOT RUN

- 11. Remove two bolts (4) which fasten fan motor mount (5) to fan modification assembly (2) and fan motor (1).
- 12. Slide fan motor mount (5) away
 from fan motor (1) to provide access to cover (16) of fan motor
 builtin conduit box (12).

- 13. Remove two screws (21) and remove cover (16).
- 14. Inspect fan motor harness (10)
 wires (9, 13 and 11) for proper
 connection to motor wires 3 (8),
 2 (15) and 1 (14). If poor connection is observed, repair connection and go to step 19. If connections are good, separate fan motor
 harness wires (9, 13 and 11) from
 fan motor wires 3 (8), 2 (15) and
 1 (14) for continuity check of
 harness. Refer to Repair of Wiring Volume 1-9, page 1-9-

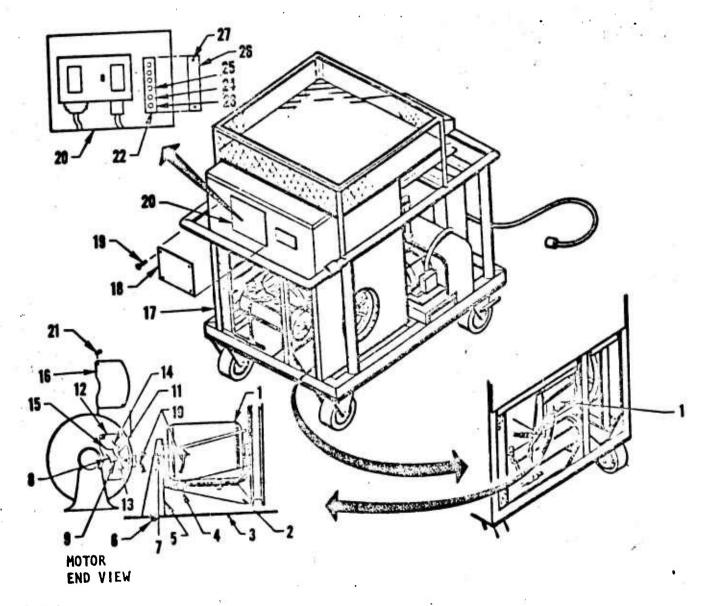
TROUBLESHOOT CONDENSER FAN NOISY OR DX NOT RUN

- 15. Set multimeter to read ohms in 0
 to 300 ohm range and zero meter.
 Refer to Test Equipment Operation,
 Volume 1-1, page 1-1-
- 16. Place multimeter leads on each of the following sets of terminal board to fan motor harness wires at fan motor checkpoints and read left to right deflection for each check.

Terminal Board TB-1 (16)	Fan Motor Harness Wires (4)
1 (23)	X3A10C (9) X2A10B (13)
2 (24) 3 (25)	X1A10A (11)

If meter deflection is observed in each check, replace fan motor (1). Refer to Remove and Install Condenser Fan Motor, Volume 1-9, page 1-9-1. If meter deflection is not observed in one or more of the checks, replace fan motor harness (4). Refer to Repair of Wiring, Volume 1-9, page 1-9-. Go to step 18.

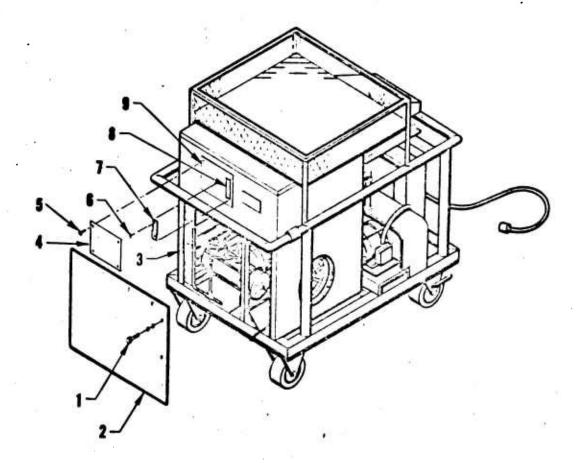
TROUBLESHOOT CONDENSER FAN NOISY OR DOES NOT RUN

- 17. Return to Checkout AGE ECU, step 8, if checkout is in progress, or place back cover (2) on cooling unit and install screws and washers (1). Go to step 20.
- 18. Place terminal board cover (7) on terminal board TB-1 (8) and install screws (6).
- 19. Place electrical box cover (4) on cooling unit (3) and install screws and washers (5).
- 20. Return to Checkout ACE ECU, step 11, if checkout is in progress, or checkout fan per steps 11 through 13 of Checkout AGE ECU.
